# U.S. Steel Tower

case study  
By Lauren Mears

Location: Pittsburgh, PA

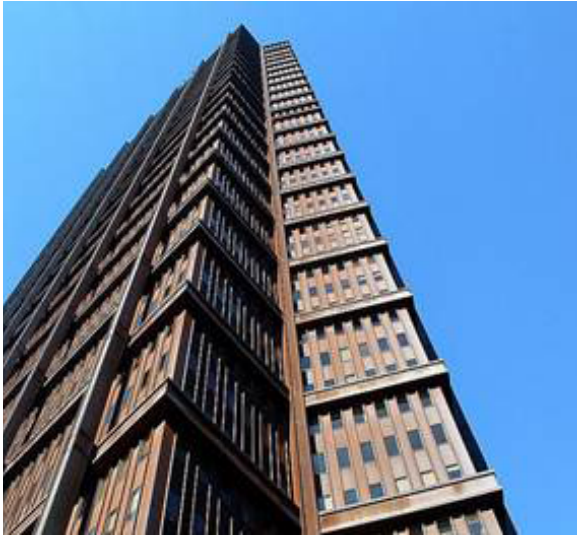
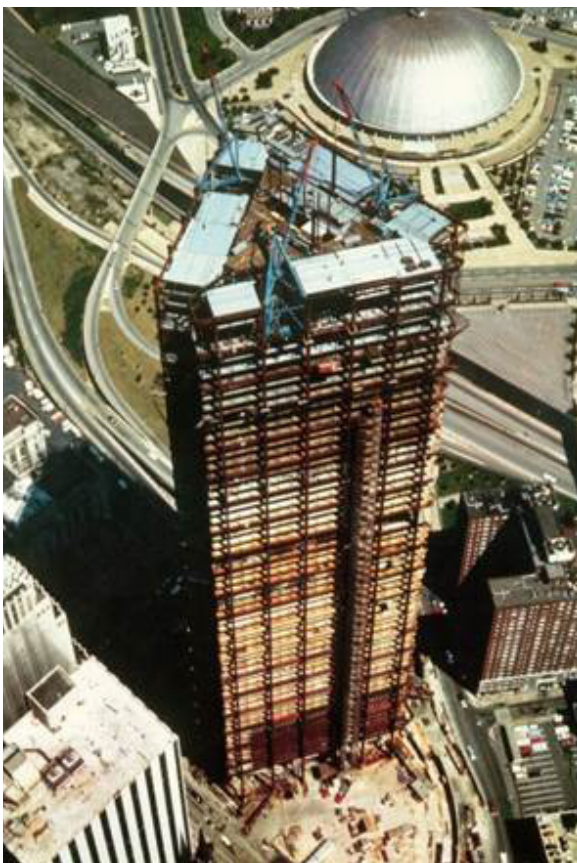
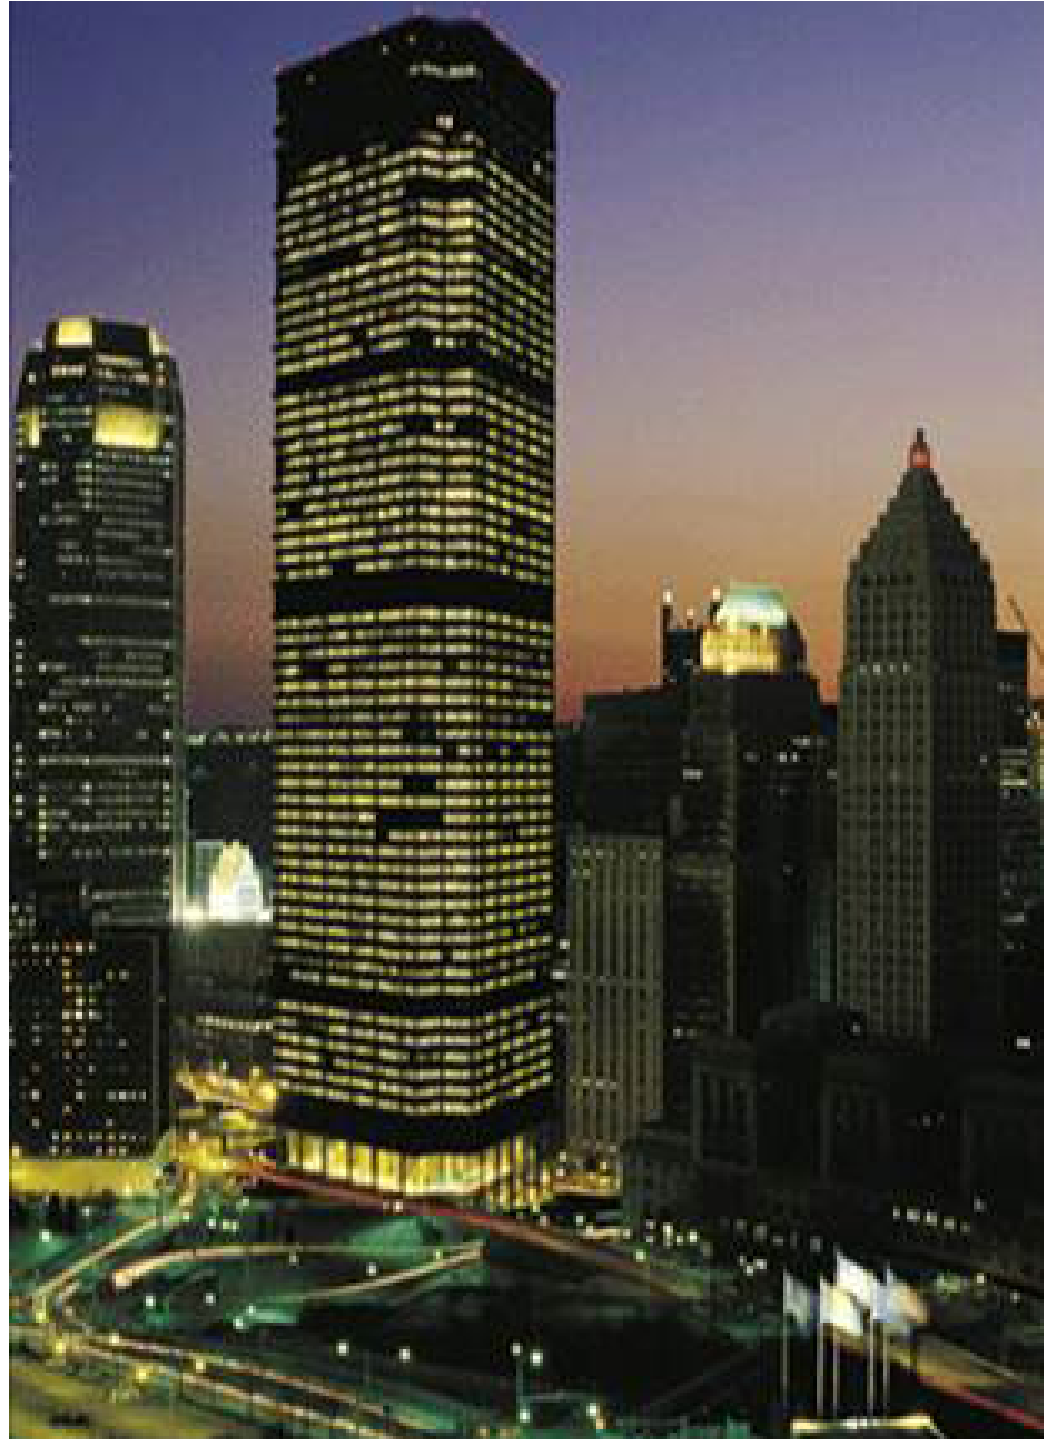
**Application:** Exterior façade and structure

**Properties of material:** First building to use steel as an exterior building material. It has a rust-like appearance due to the exterior application and support material Cor-ten. Cor-ten resists the corrosive effects of rain, snow, ice, fog, and other conditions by forming a coating of dark brown oxidation over the metal, which inhibits deeper penetration and negates the need for painting and costly rust-prevention maintenance over the years.
